NAVORD REPORT 2830

INVESTIGATION OF PREMATURES EXPERIENCED
IN MAJOR CALIBER PROJECTILES

27 JULY 1953

U. S. NAVAL ORDNANCE LABORATORY
WHITE OAK, MARYLAND

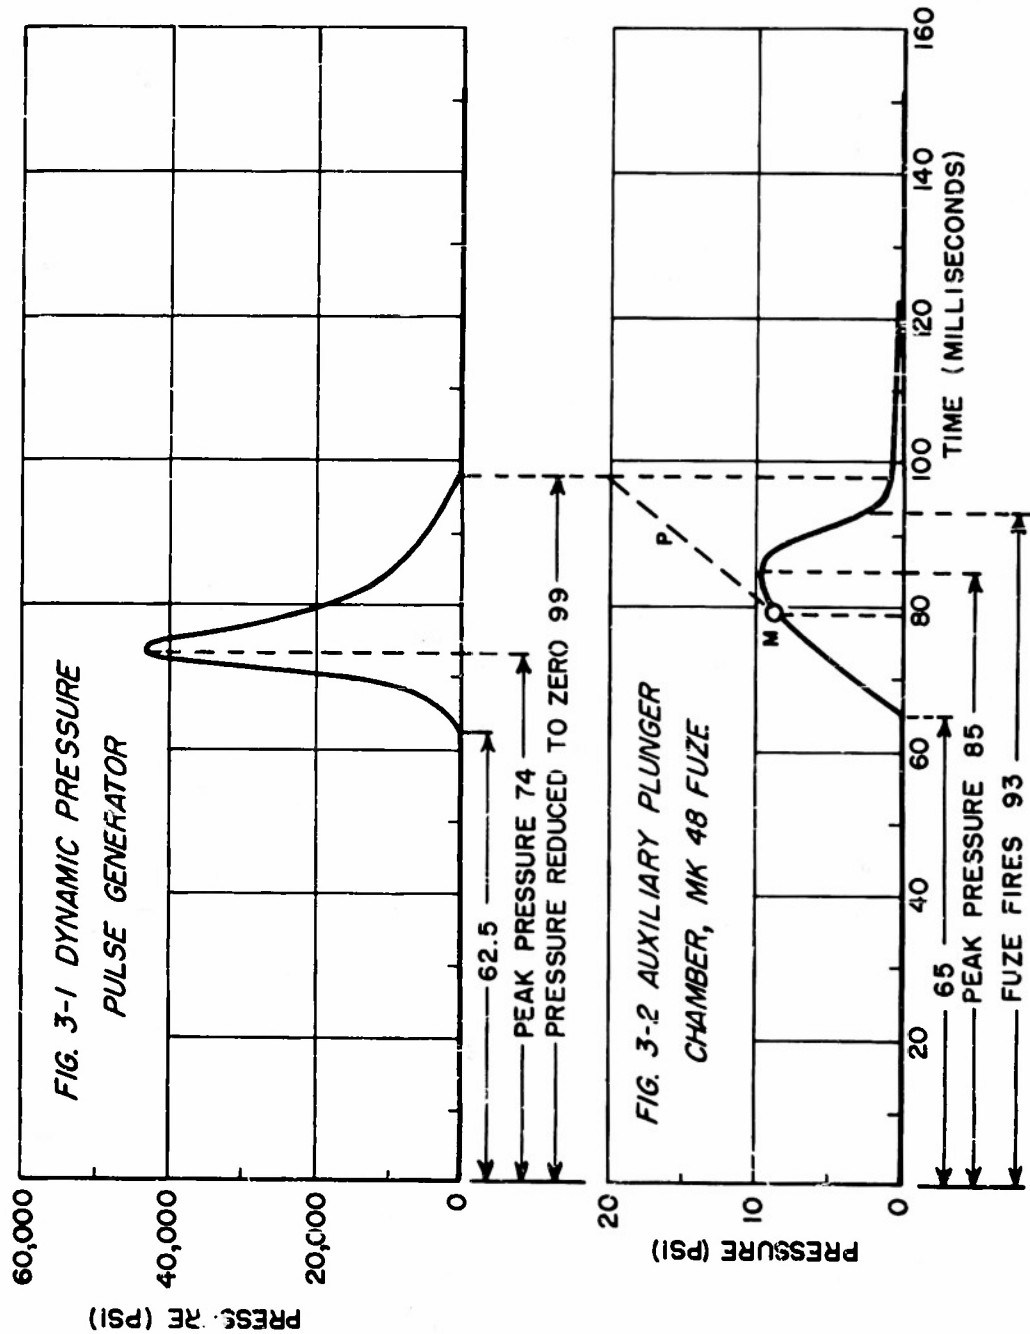
19. In test No. 15, the fuze fired with a 10 p.s.i. pressure peak in the auxiliary plunger chamber. The pressure-time characteristics of the leakage pulse are shown graphically in Figure 3-2. The firing time noted in the graph was measured by starting a Potter time when the firing circuit was closed and stopping it by shorting the timer on plunger impact with the sensitive firing pin. The fuze fired in this test before the Thundermug pulse (plotted in Figure 3-1 for comparison) had reduced to zero. In action firing the detents would prevent plunger movement until the projectile left the bore, thereby causing a continued leakage into the fuze similar to the dotted line P in Figure 3-2. This would result in a peak pressure of approximately 20 p.s.i. As seen in the graph, the pressure build-up is linear to point M and then flattens and diminishes. Because relatively high Thundermug pressures still exist, one can assume that the decreasing rate of build-up is due to an increasing volume as the plunger moves and that the plunger begins accelerating at point M or 79 milliseconds after closing the firing circuit. Since the sensitive primer fired 93 milliseconds after starting the test and there is a 10 millisecond explosive delay in the Mk 48 Fuze, this shot represents a premature occurring 24 milliseconds after the projectile leaves the bore or at a distance of 52.8 feet if an 8"/55 reduced charge was used. Actually, the peak pressures in the tracer cavity plug voids are higher than those in the auxiliary plunger chambers and gases will continue to flow into the plunger region for a short period after the projectile leaves the bore. This could cause prematures to occur at distances greater than 52.8 feet. Tests Nos. 19-26 were conducted to determine the pressures that any gas seal would have to withstand if the

FIG. 3
PRESSURE PULSE CHARACTERISTICS

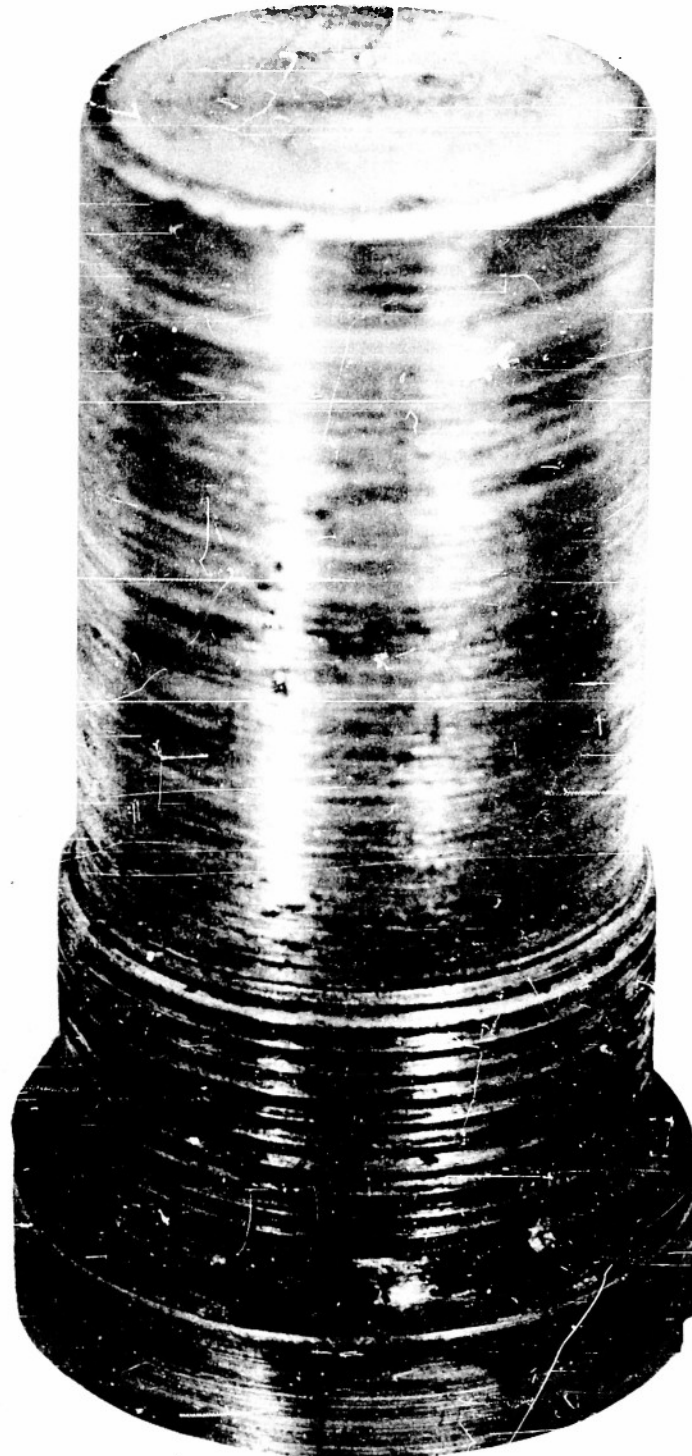
In test Nos. 6, 7, and 11 (Table 2) carbon deposits were found on the tracer cavity plug threads even though the fuzes did not premature. Gas leakage occurred past a normal lead washer seated properly in Test No. 11. This shows that gas leakage does not necessarily result in a premature and also that the sealing qualities of the lead washer alone are not satisfactory. A comparison of shots Nos. 11 and 12 indicates that the difference in friction, weights, and relative positions of fuze components due to tolerances also affect the malfunctioning of any one leaker. In test No. 3 the portion of the lead sealing washer exposed to a 3/5 diameter wrench hole in the base of the fuze melted and formed an enlarged hole (Figure 4). The erosion effect of the high temperature gases leaking into the fuze is clearly defined. The wrench hole in the fuze body is outlined by carbon residue on the tracer cavity plug. With extreme tolerances the conical tips of the wrench holes are .021 from the face on the fuze body on which the .025 lead sealing washer is seated. The .025 thick washer must be compressed .00+ to .021 to avoid direct exposure to gases.

FIG. 4 EFFECTS OF GAS EROSION ON
A NORMAL LEAD WASHER ASSEMBLED
IN A MK 48 BASE FUZE
CONFIDENTIAL

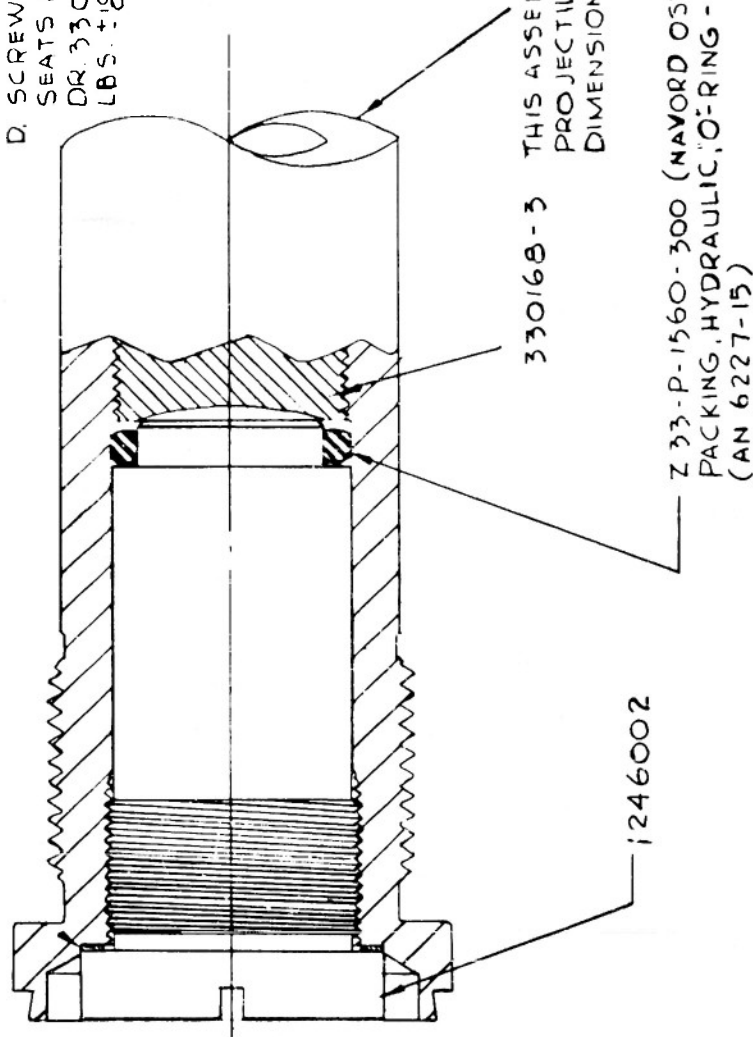
21. The method of sealing devised to prevent propellant gas leakage into the fuze incorporates a synthetic rubber "O"-ring (Z33-P-1560-300 NavOrd OSD 600) (AN 6227-15) placed around the tracer cavity plug at the nose end. Details of this assembly are shown in BuOrd drawing Nos. 1246001 and 1246002, Figures 6 and 7, respectively. The tracer cavity plug, Drawing No. 1246002, Figure 7, has been modified from the existing tracer plug not only by the presence of the shoulder for the "O"-ring, but also in the dimensioning of the length of the plug which assures seating of the plug on the plunger retainer under all conditions.

FIG. 6 TRACER CAVITY & PLUG ASSEMBLY DETAIL

46. The Laboratory recommends that the "O"-ring gas seal, Figures 6 and 7, BuOrd Dwg. Nos. 1246001 and 1246002 respectively, be utilized as the best way to effectively eliminate gas leakage in the present designs of the Mk 28 and Mk 48 Base Fuzes.

C. COAT ALL THREADS OF PLUG WITH FUZE THREAD LUTING (UNDILUTED) MADE IN ACCORDANCE WITH NAVY DEPT SPEC. MS 603.

D. SCREW PLUG INTO TRACER CAVITY UNTIL IT SEATS AGAINST PLUNGER RETAINER PLUG, DR. 33016B-3, USING A TORQUE OF 40 FT. LBS. \pm 18 FT. LBS.

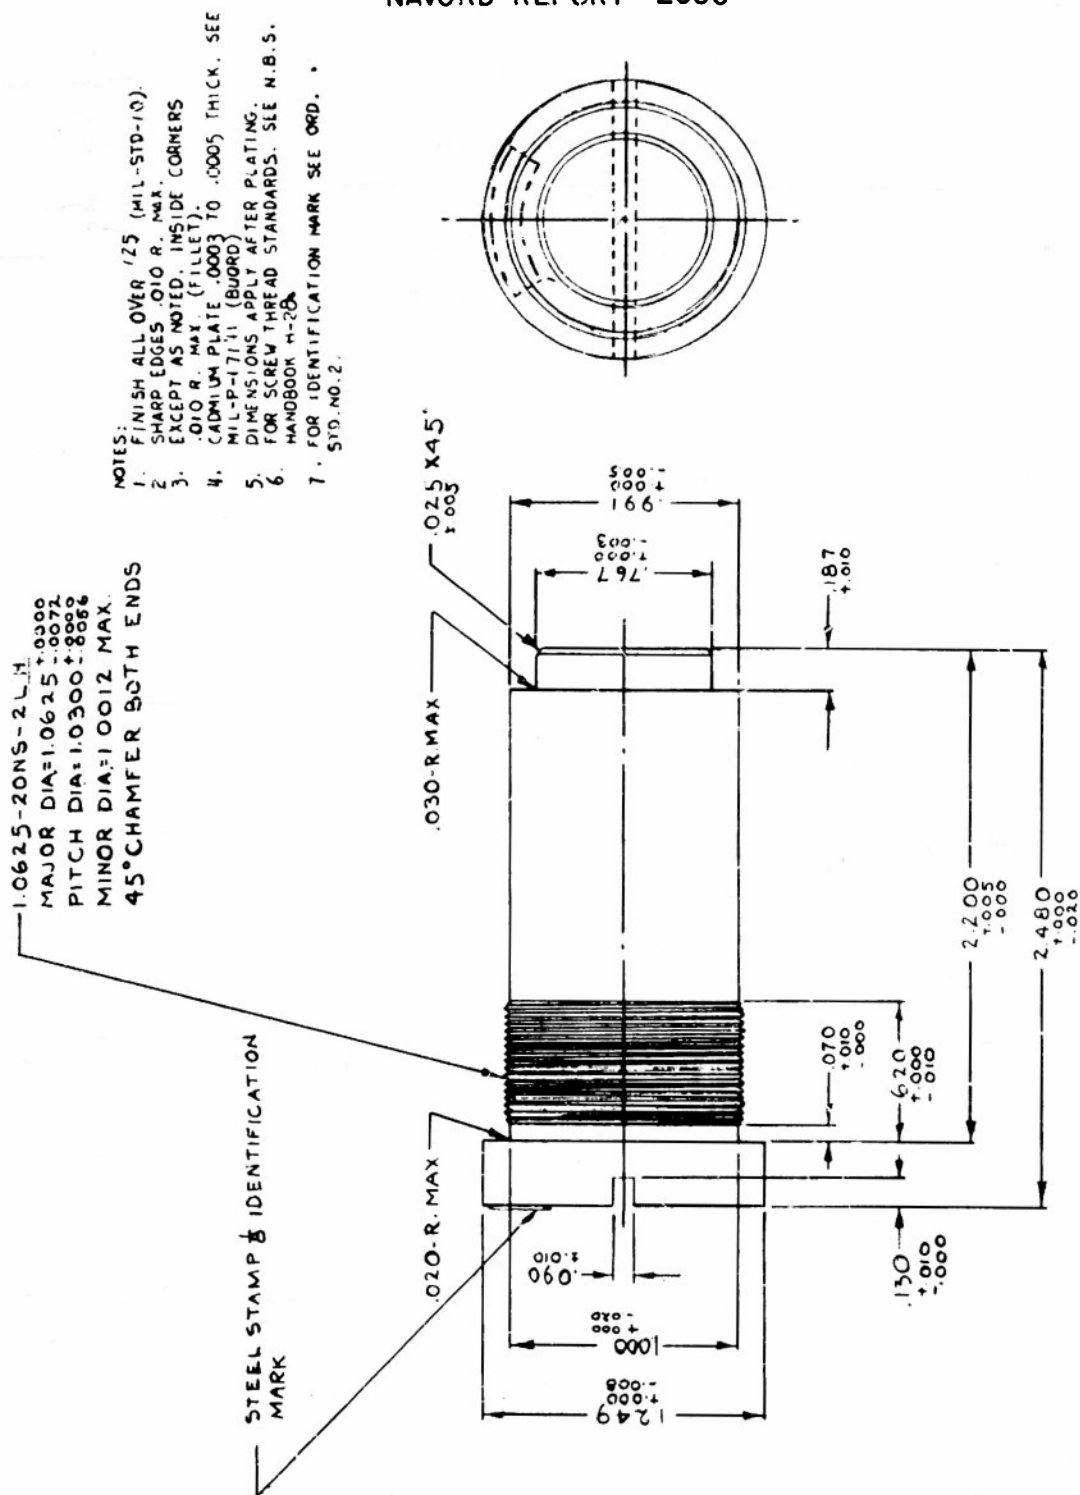
FIG. 7 TRACER CAVITY PLUG
FROM BUORD DRAWING NO. 1246002

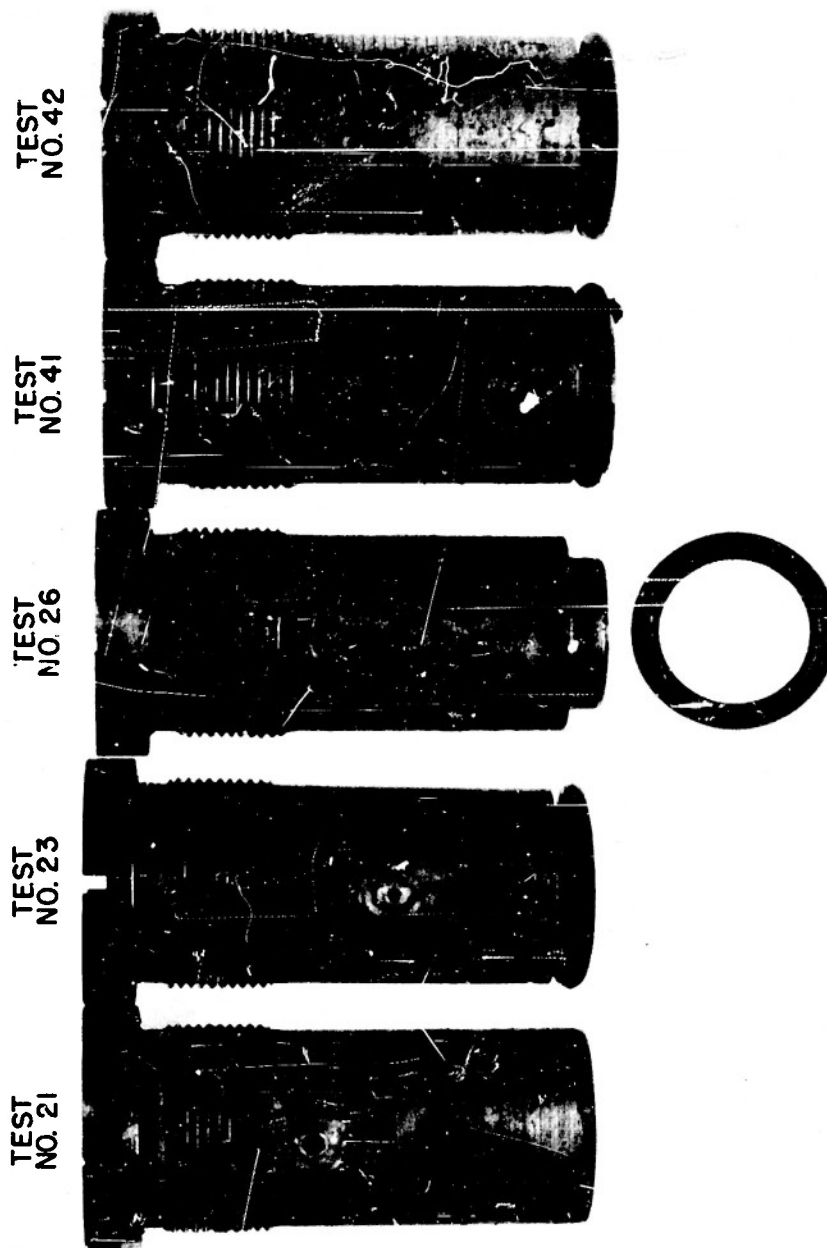
FIG.8 EFFECTS OF GAS EROSION OF A 0.040 HOLE IN MK 5
TRACER WITH AND WITHOUT AN "O"--RING SEAL
